Part 1: Existing Conditions Report

TOWN OF WESTPORT, NEW YORK

WESTPORT TOWN OFFICE BUILDING BUILDING RENOVATION FEASIBILITY ASSESSMENT EXISTING CONDITIONS REPORT

January 9, 2013

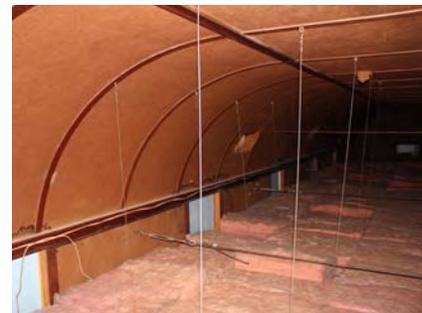
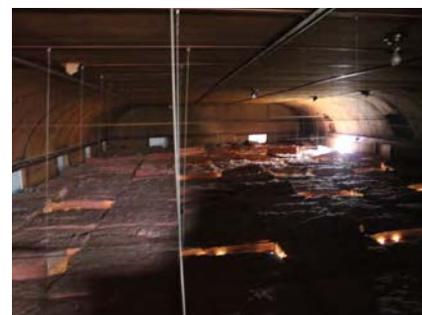
Insulation above Drop Ceiling

Roof – The existing roof of the building is not insulated. The dropped ceiling however does have approximately 8” of fiberglass batt insulation placed on top of it. The batt is fairly continuous, but has clearly been disrupted in several places.

R=28 (if insulation were continuous, properly installed, and contained within the roof envelope), but probably performs as if R=15 - 20.

1. There is obvious evidence of medium sized mammal occupation/activity in the attic. Possibly raccoon, possum, etc.
2. There is some evidence of water damage at the chimney and eaves, but otherwise the roof seems to be sound and is keeping the interior structure and space dry.
3. Gable end vents appear to have been added for attic ventilation, probably at the same time the ceiling was dropped over meeting space.

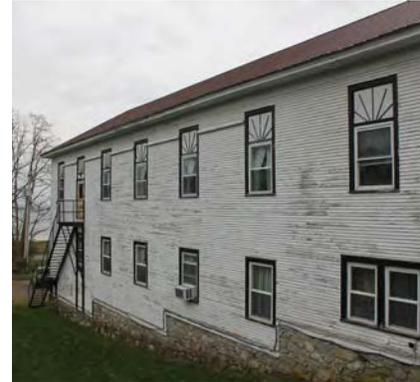
Exterior Facade Facing North

Exterior Walls – The existing exterior walls on the Upper floor level do not have any insulation in them. Instead of gypsum wall board (sheetrock) on the interior, the walls are clad with “insulating lumber,” by Cellotex. On the lower level, the walls have been insulated with fiberglass batt. Without doing an infrared scan, it is difficult to determine its effectiveness, but it would seem that the batts have slumped between the studs. Allowing for greater heat loss at the top of the walls. Windows are fairly new, double pane units on both the upper and lower levels. No air sealing is apparent around windows, doors, or other openings.

Upper Floor – R=5-10

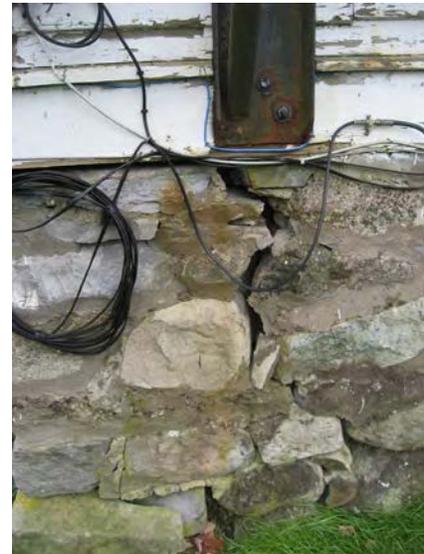
Signs of Movement in Foundation

Foundation – There is not damproofing, waterproofing, or insulation on the foundation walls. There is clear sign of some water damage, or movement at the foundation walls and exposed footings/piers.

3. Lower Level Moisture: Water and moisture issues in the ground level should be mitigated in an attempt to reduce observed settlement and wall movements. A sub-grade drainage system and covering of concrete mud-mat or functional slab is a recommended approach. Front wall drainage is also a likely related effort to undertake. With the moisture lessened, foundation and wall distress repairs could then be more reliably undertaken. The foundation in the back may lack adequate cover for frost heave resistance. A ground insulation system could address this condition.

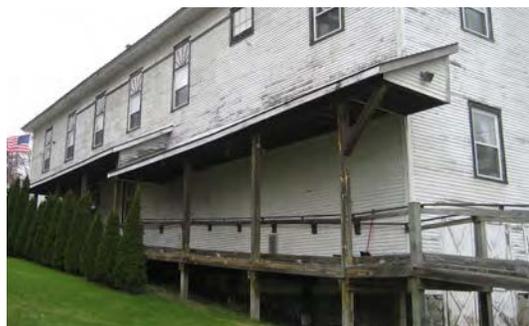
Exterior Covered Walkway

The building is accessible at the main level from Champlain Avenue and at the lower level from a very long, covered ramp that lands in the parking area behind the building to the east. The ramp as it was designed does meet code, although it has come out of alignment in places, for example at the doorway, and needs some repairs to bring it back into full compliance. The basement level is accessible at grade on the east side of the building. The rest rooms on both levels do meet accessibility requirements (for access by persons with wheelchairs).

A wood ramp and roof structure has been added to the south face of the building to access the middle floor. In general The wood shows signs of long-term weathering. Wood connections do not appear to have been formally engineered or are in need of augmentation due to wear from, it is suspected, snow falling from the higher roof. Alternatively, the structure, as it lacks the apparent heartiness of the original building, may be economically rebuilt or have its function relocated - to increase its durability. It is advised that caution be used by limiting access during times of active, large sliding snow events from the higher roof.

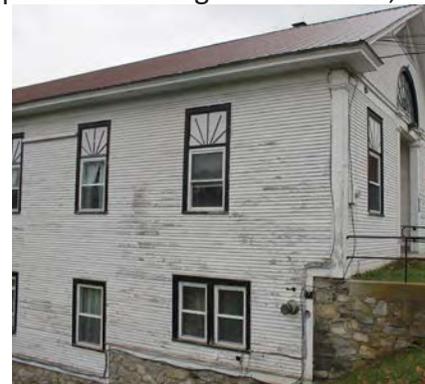
Typical Exterior Finishes

Exterior – The building foundation is masonry, stone and rubble. The mortar appears to be in fairly good condition on the exterior. The exterior building siding is a spruce clapboard with a +/- 3” exposure, which appears original to the building. The clapboards are in good condition, but in need of paint. The roof, while showing very little signs of failure (leakage), is corrugated metal. It is showing signs of corrosion. Photos from the 1960’s show asphalt shingles on the roof and evidence of the asphalt roof is still visible from the exterior. We believe that the metal roof, installed in the mid-1980’s, was installed on top of the asphalt roof. There could be another asphalt roof beneath this one, or one that was replaced prior to the one that shows up in the 1960’s.

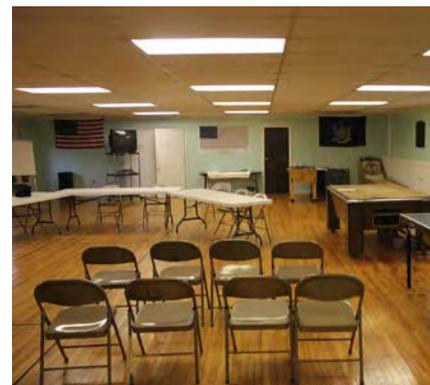
Interior of Main Room at Upper Floor

Interior – The meeting hall on the main floor is a 2” wide strip floor running longitudinally (east-west). The walls are painted Cellotex. A wood wainscot exists to the height of the window sills. All are in fairly good condition. The ceiling is a dropped 2’-0” x 4’-0” acoustical ceiling tile, which is showing signs of wear and moisture in a few places. The clerk’s office and the lower level offices and court spaces are carpeted with wainscot to 40” above the floor in most places. The walls are gypsum wall board (sheetrock). The ceilings are 2’-0” x 4’-0” acoustical ceiling tile. The carpet is likely harboring dust and mildew and impeding the indoor air quality of the spaces where it is located. The gypsum wall board is in decent condition and the ceiling tile is showing signs of wear in a few locations. We did not explore what is under the carpeting on the Lower Level.

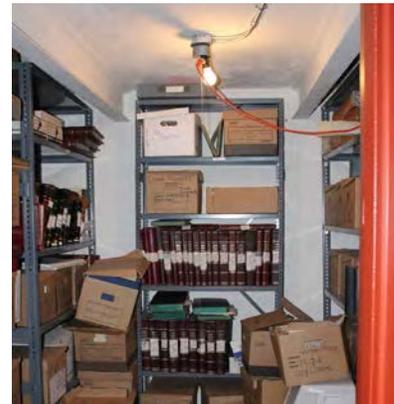
Interior of Vault

The vault is constructed of concrete block and a poured concrete ceiling, supported by steel beams running longitudinally.

The vault is in good condition.

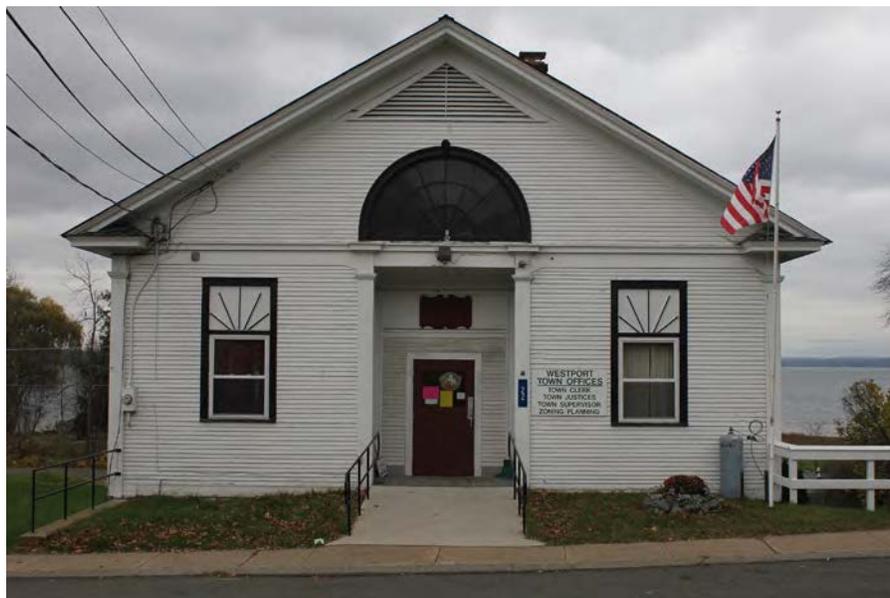
Main Entry Facade

1. Gable-end, arched-top window over the main entry is definitely worth restoring and exposing.
2. The main entry could be restored to its original splendor.
3. Other mouldings and woodwork inside and out are worth restoring.

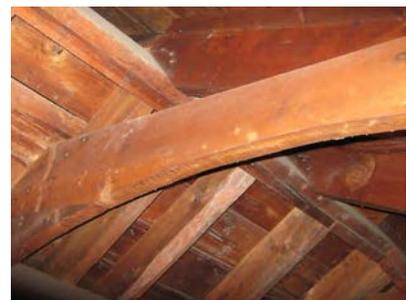
Shouldered Roof Truss at Exterior Wall

1. Roof Augmentation: The roof truss and rafter structure exhibits spreading and deflections that have been addressed in part by tie-rods schemes. There are related signs of distress in the connections of the curved truss supports. A combined effort to augment the trusses at the ends and across the bottom chords can address these conditions. The augmentation could involve a combination of wood and steel framing. Note that this

A few selected roof and floor framing areas were evaluated for gravity load. Note that the truss ends at the curved shoulder were found to be the element controlling the capacity of the roof framing. The wind, seismic and earth load effects were as not formally studied at this juncture.

is recommended for low scale renovations to the roof only, such as insulation improvements or significant re-roofing. The augmentations could accommodate design options like exposing the trusses (with augmentations) or having insulation above the existing roof sheathing.

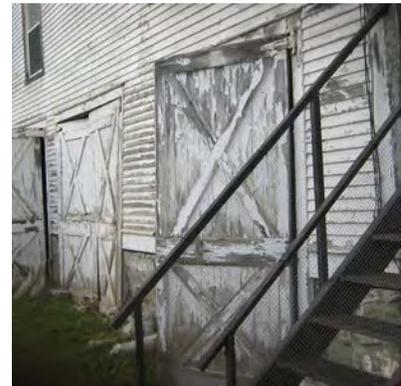
Back Wall at Lower Level

2. Lateral Load Resistivity: The whole lateral load resisting system, present now the exterior wood walls, floors and roof, should be brought up to current code standards. The most acute issue would involve addressing the three-story back (east) side of the building, where the openings at the ground level, heavily perforate the system. An upgraded system might involve concealed steel strap bracing and structural augmented foundations (such as helical or rock anchors) , as well as the loss of a door. The front (west) wall would likely to be similarly affected. Wood framing upgrades involving a blend of new steel strapping with wood end posts to the long north and south faces is likely needed. Also, steel strapping or added sheathing within the floor and roof framing planes is likely required to distribute the loads to the walls. This would be less invasive to existing wood surface materials if done from the bottom and inside of floors and walls. Having been built in an era before seismic requirements were codified, many similar structures of this type require retrofit measures on some level measures for revitalization.
