Westport Town Office Renovation

Existing Conditions

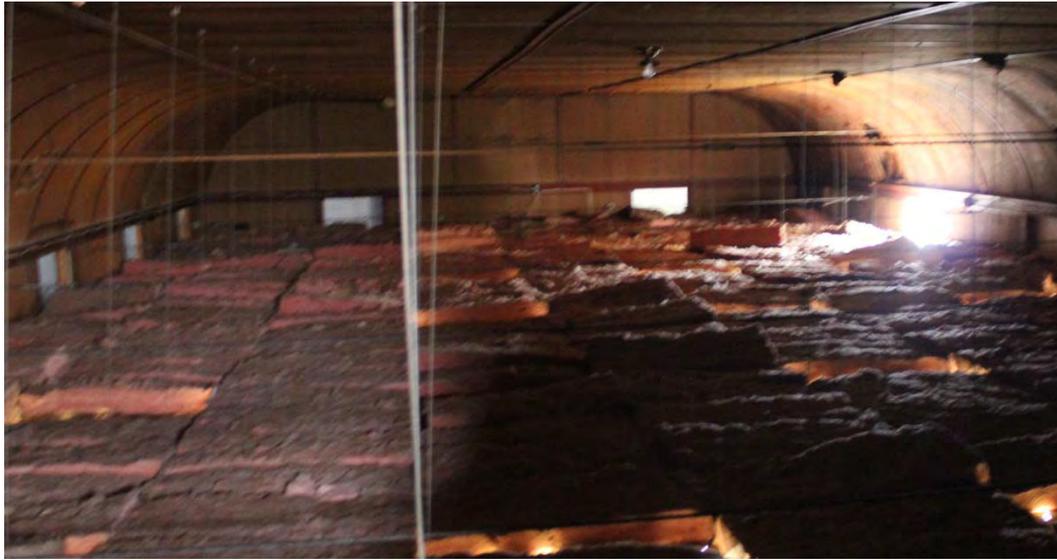
Insulation above Drop Ceiling

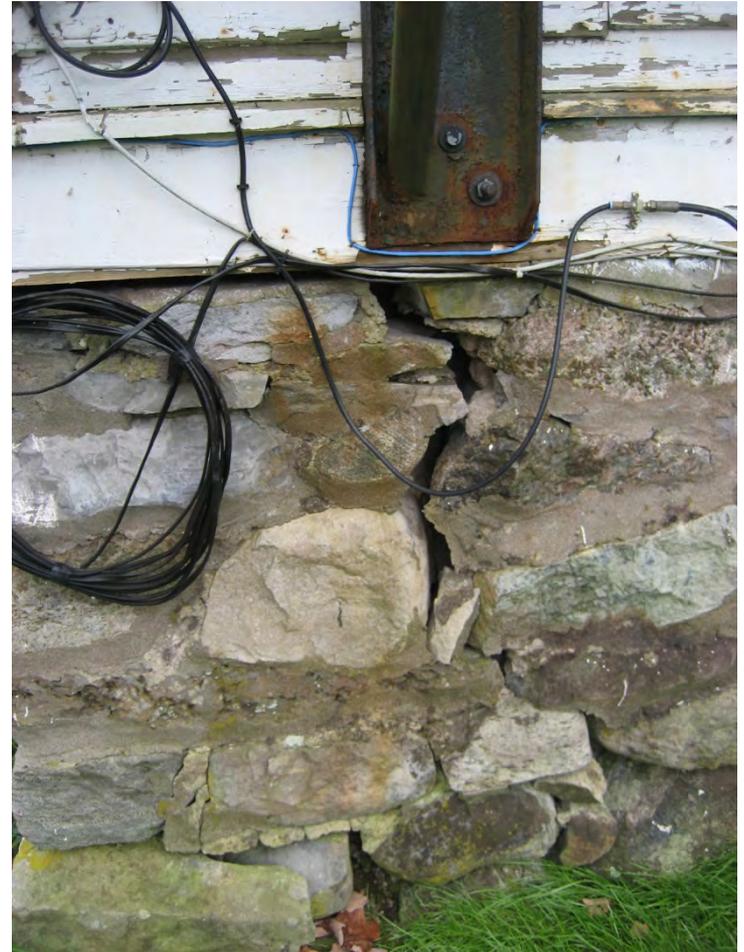
Signs of Movement in Foundation

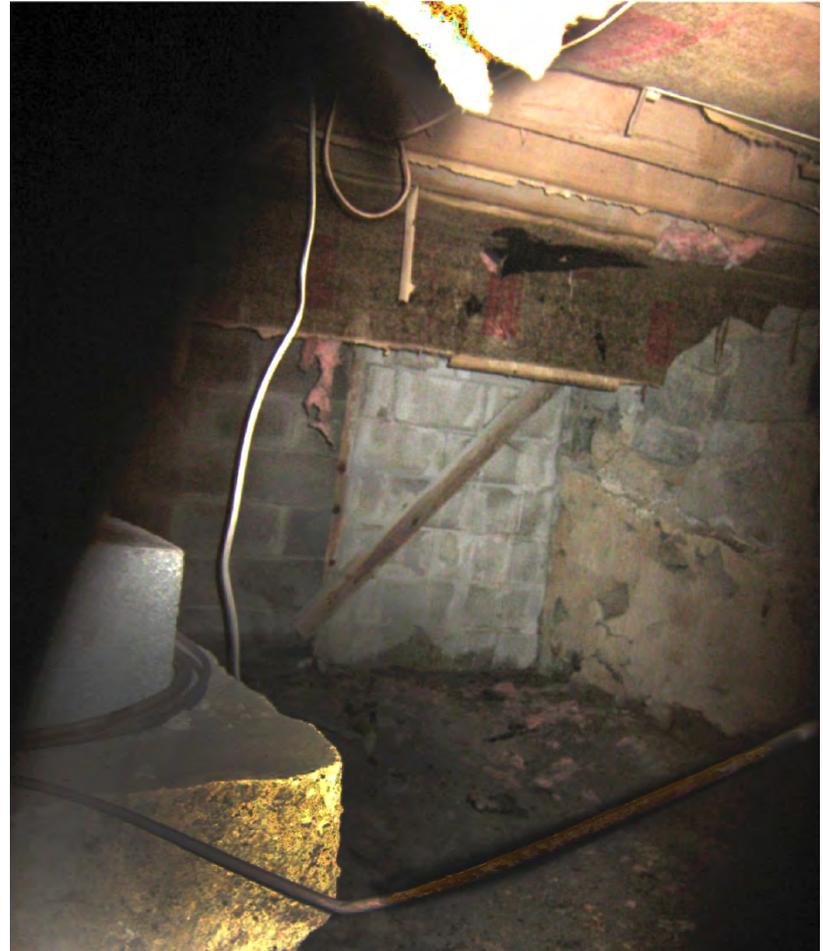
Saturated Earth at Basement Level
